2021 Accessibility Audit - Final Report

The Gem of the West Museum

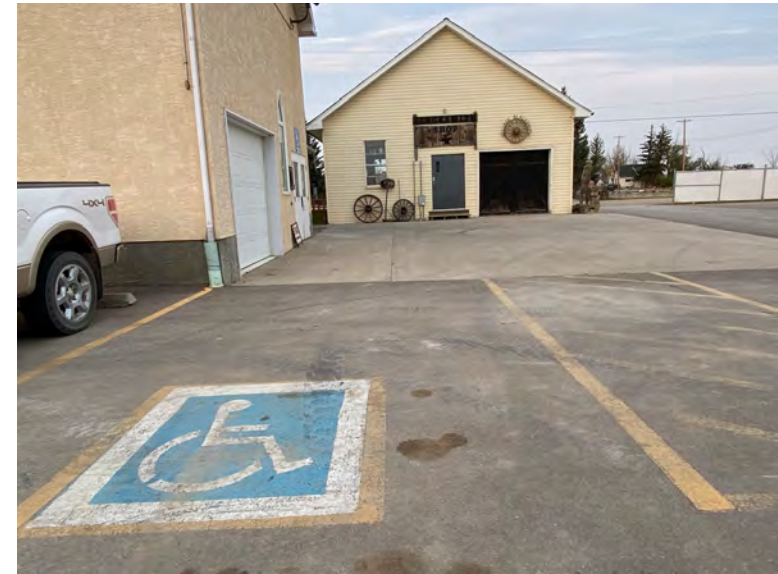
Parking

The number of barrier-free parking stalls at the Gem of the West Museum is adequate and meets the Land Use Bylaw requirements. However, the parking stalls could benefit from vertically mounted barrier free signs to ensure the accessible stalls are visible during the winter months.

- » Install vertically mounted barrier free signage at existing stalls as per building code

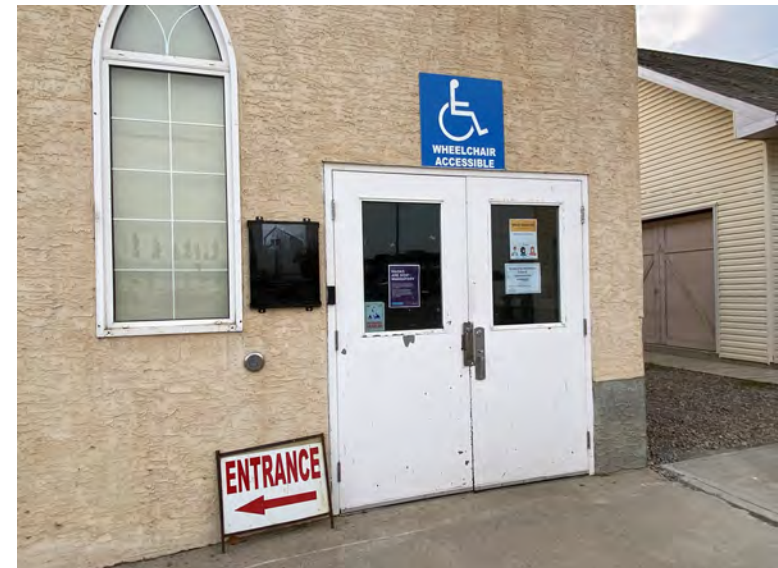
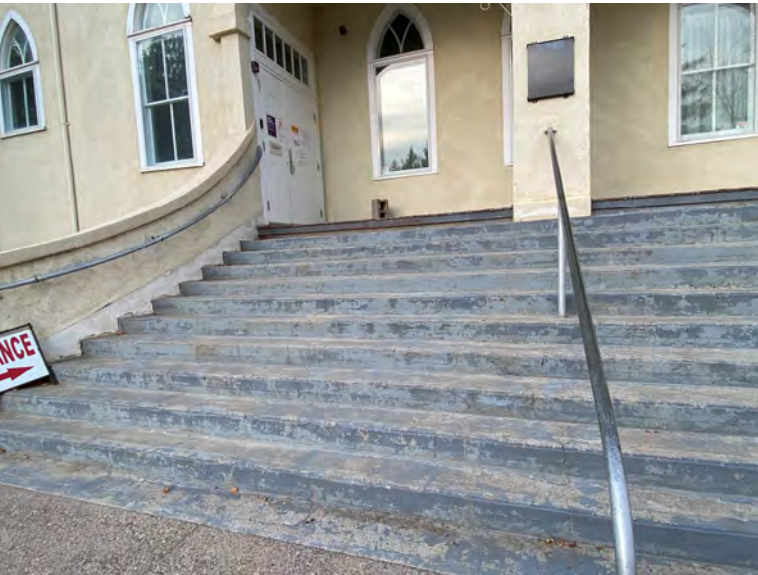
North Entrance

Given the north entrance is the only accessible entrance to the building, it is recommended that it be indicated as such by signage that is visible from the east entrance to the parking lot. Following entering the building, it was determined that the ramp leading into the building was over the suggested 1 in 12 running slope; the length of the ramp exceeded the 9 m maximum length without a landing. There was no level area at the bottom of the ramp at the exit door.

- » Provide signage perpendicular to the building face indicating the accessible entrance
- » Provide a landing at the base or middle of the ramp in conformance with the building code

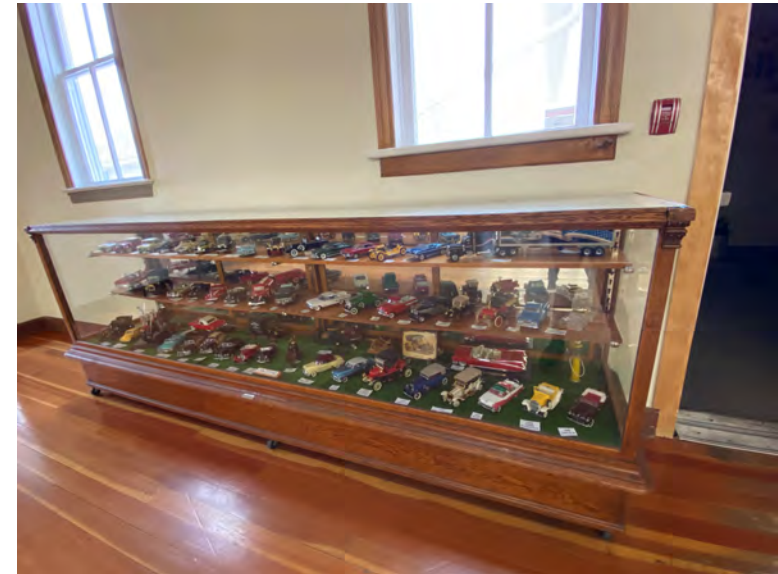
Exhibits and Displays

There are a number of exhibits and displays within the museum that are positioned at different heights.

- » Display exhibit items in a lowered exhibit case to ensure items are at an eye-level view for persons in wheelchairs and young children
- » Labels and description tags on upper shelves should be semi-vertical so they can be read by persons in a wheelchair

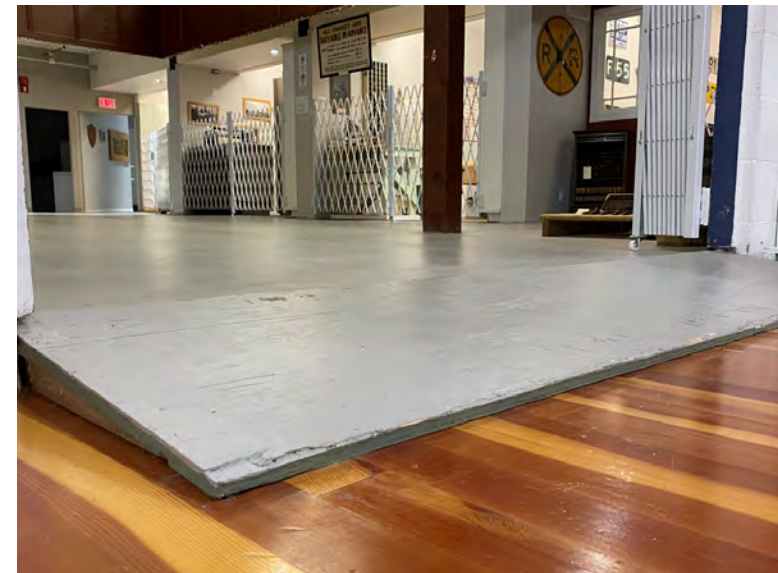
Floor Transitions

On the lower floor there are numerous locations where the floor surface has transitions which can pose a tripping hazard or be difficult to negotiate in a wheelchair

- » Provide sloped smooth transitions (concrete topping or metal) where possible. Or highlight edges with highly contrasting colour to identify the danger
- » Alternatively, consider levelling the floor with low profile raised floor systems over larger areas. These systems can also carry electrical and communication cables for displays

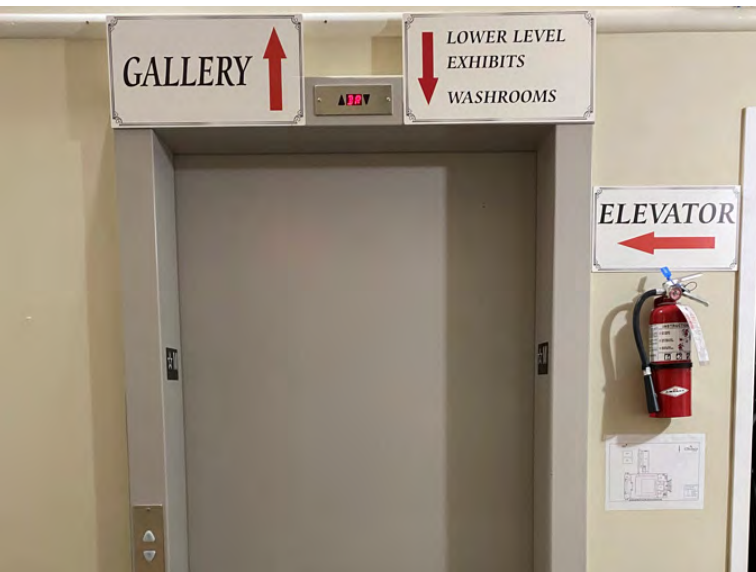
Signage

A variety of accessibility signage throughout the museum is located above the suggested accessible height and could be relocated to be at a comfortable eye level for able bodied persons and persons with disabilities.

- » Relocate signage to a 2000 mm maximum height (signs should be large enough and just above the average ambulatory head level so they can be viewed easily)

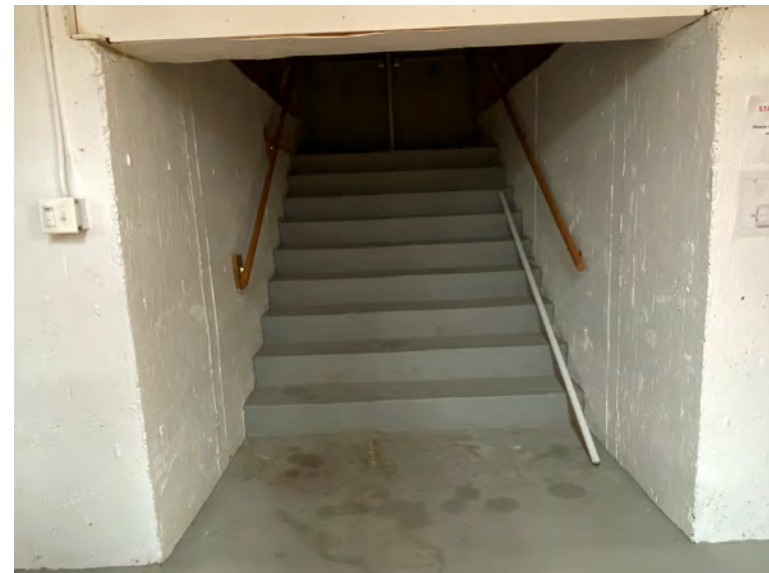
Lower Floor Emergency Exits

Following a review of the lower floor it was determined there are two emergency exits from the building and neither are accessible. The only accessible exit from the basement is the elevator.

- » Persons with accessibility issues will require assistance in exiting. Ensure staff are trained to look for persons requiring assistance before exiting or provide a safe refuge area while waiting for emergency personnel to arrive

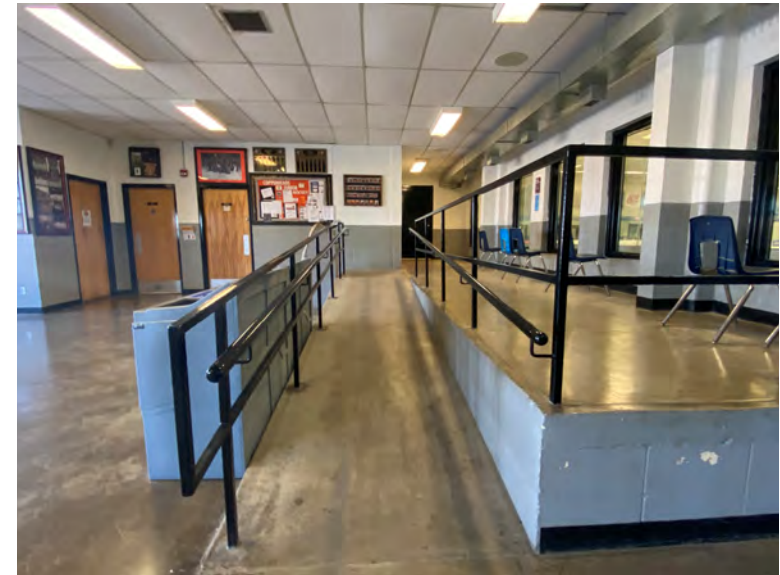
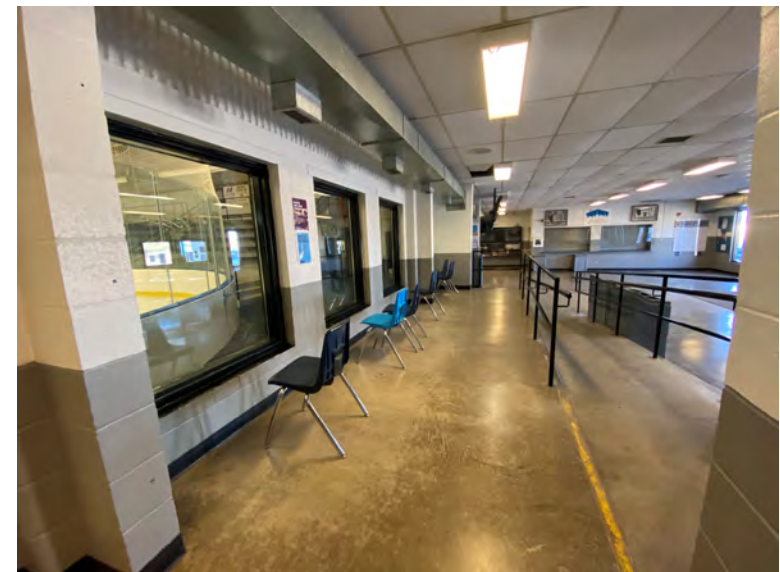
Viewing Area

Within the arena foyer, a viewing area is accessible by ramp, which is a comfortable slope for an individual using a wheelchair. Currently, there are no designated spaces for a person in a wheelchair in the viewing area.

- » Install decals on windows to identify reserve space(s) for person(s) with disabilities
- » Ensure decals are positioned as to not obstruct the view of the individual
- » Ideally; mark both the bottom and top of ramp with colour contrasting strips to assist persons with low vision identifying a transition stage
- » Alternatively install rubber floor covering with low profile transition strips at the top and bottom. This will help the slip resistance on the ramp in case of water

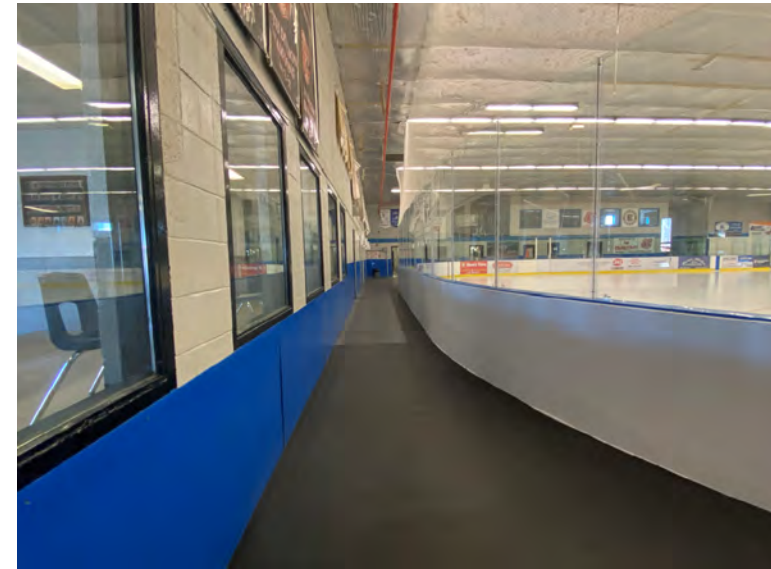
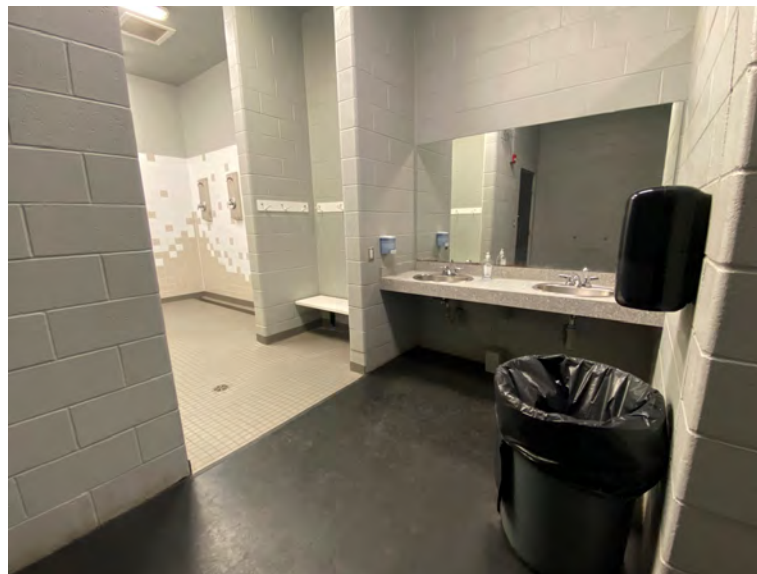
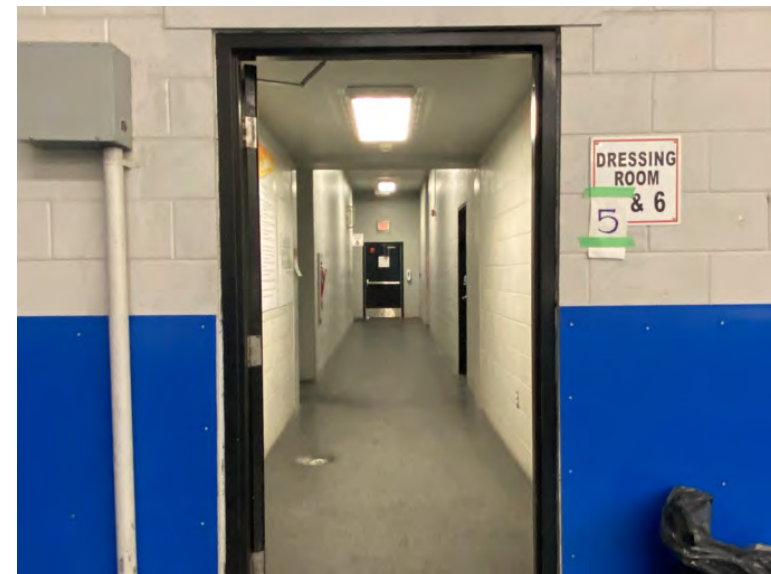
The Copperheads change rooms are located on the east side of the facility. The route leading up to the change rooms is accessible. The change rooms, bathrooms and showers are accessible and minimal improvements are recommended.

- » Install auto operator on door between ice area and locker rooms as there is insufficient clearance on the locker room side of the door. This will also assist players with sticks and bags moving through the doorway

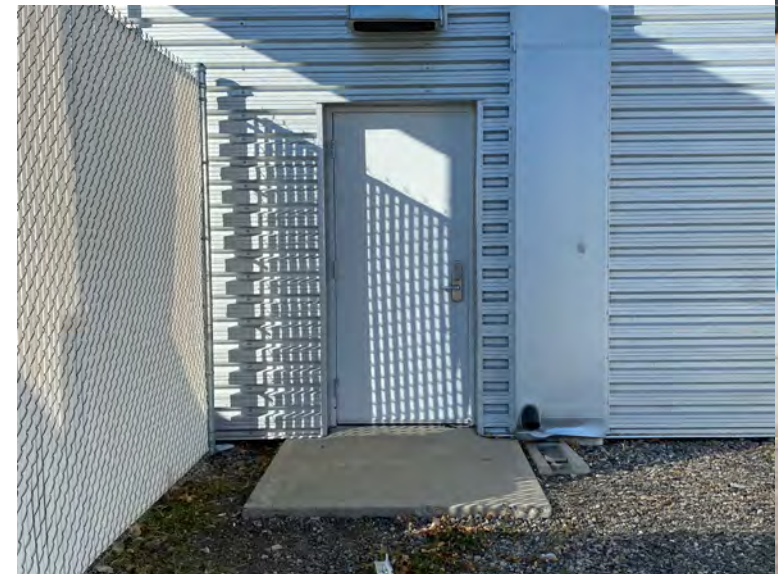
Emergency Exits

Within the arena there are various emergency exits throughout the building. One example is the east facing exit that has a concrete pad at the exterior exit that requires a person to step down to safely exit.

- » If a wheelchair bound person needs to use this exit they will require a hard level pathway to move away from the building and clear the exit

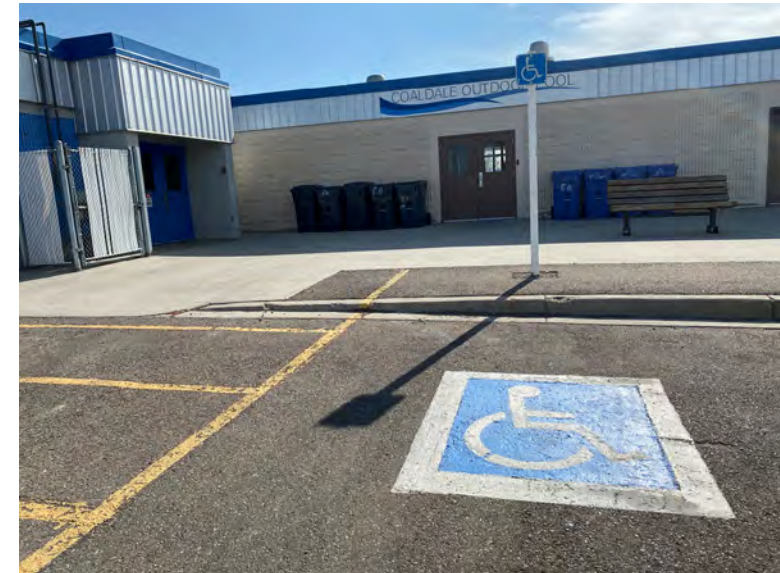
Parking

The number of barrier-free parking stalls at the Coaldale Pool are considered adequate for the facility. There is also a smooth transition from the parking lot to the main entrance with a minimal slope. Signage is vertically mounted allowing for high visibility and an unloading area is located on the east side of the parking stall.

- » None

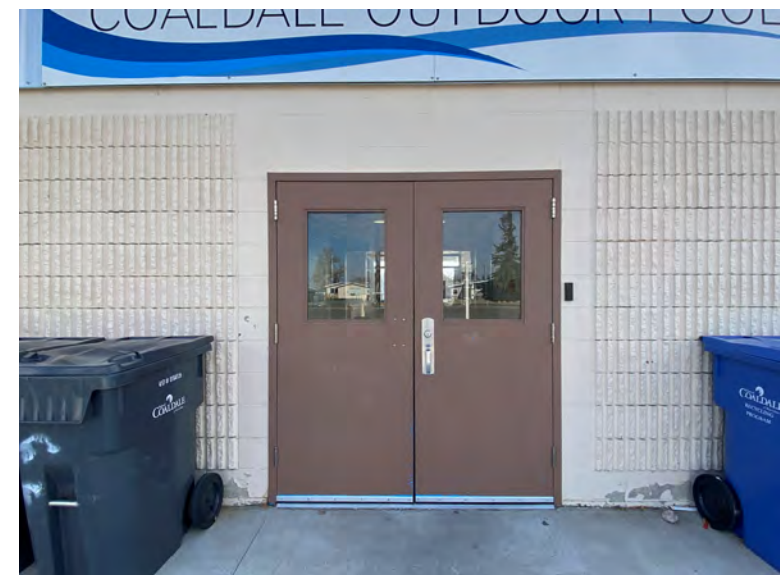
Main Entrance

The main entrance of the Coaldale Pool is not power operated making it non-accessible to users. As this is the only entrance to access the facility, it is recommended that a power-operated door be installed.

- » Provide a power-operated door for ease of access for persons with disabilities

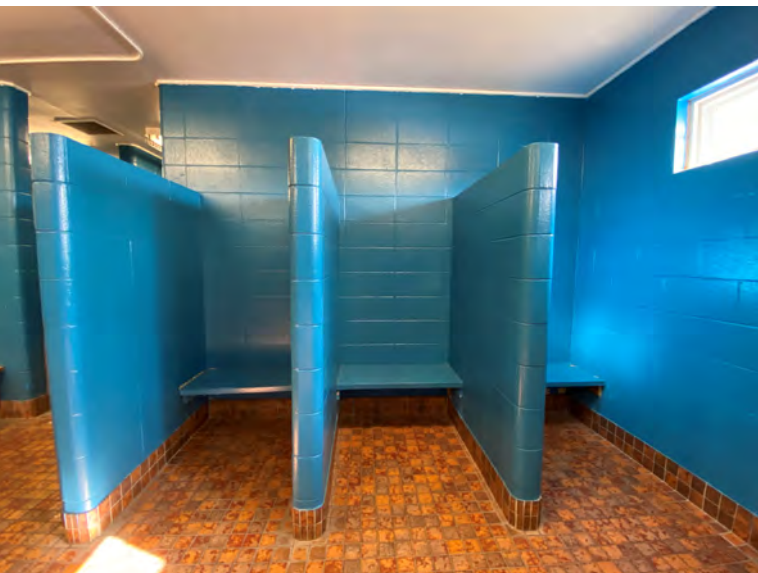
Changeroom Entrance

The entrance of both changerooms do not meet the minimum barrier free path of travel requirements. Entrances with an L- configuration requires a minimum depth of 1200 mm to allow a wheelchair to turn the corner with ease.

- » Given the change room washrooms may be too expensive to modify it may be more practical to create a separate universal accessible changeroom(s) to accommodate persons with disabilities
- » If change rooms are modified to be accessible; relocate concrete block partitions at entrance and redesign lockers and benches to allow 1200 mm wide access
- » Create a locker and bench area or private stall to accommodate wheelchair user and attendant

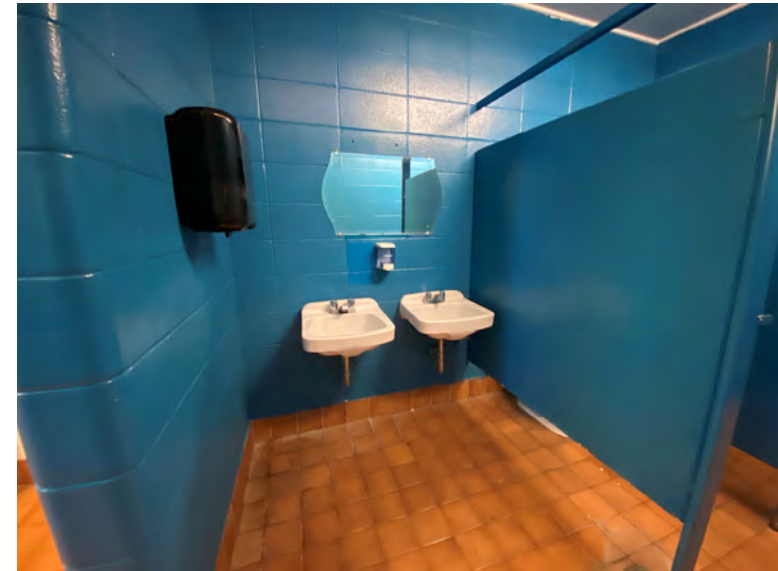
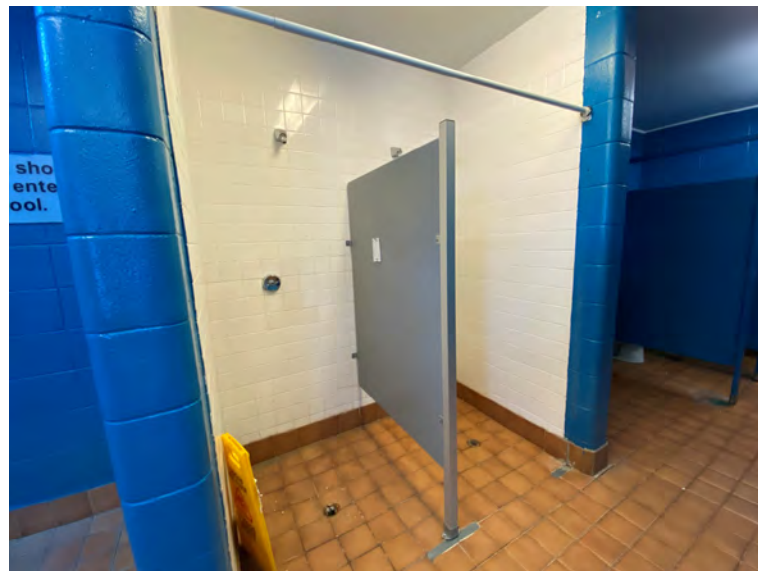
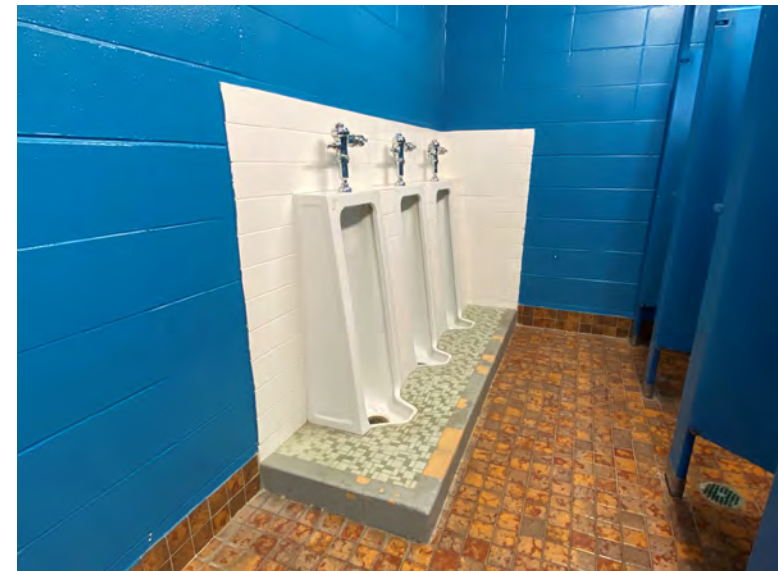
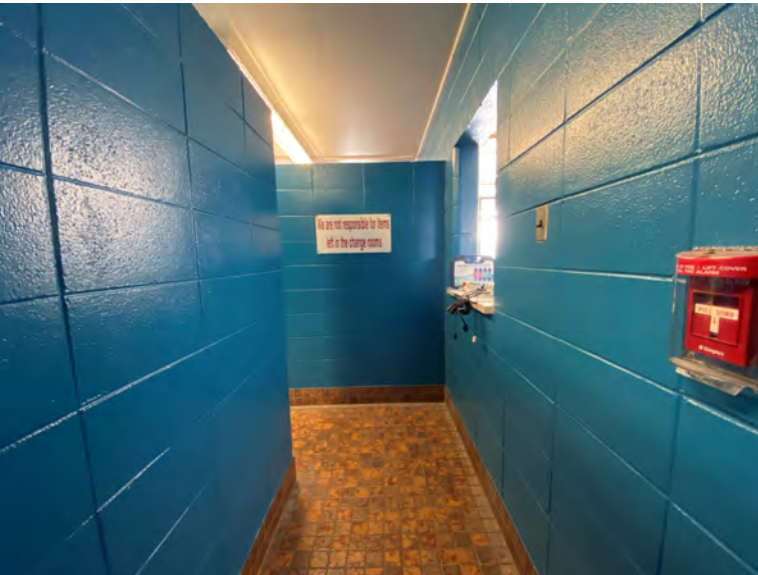
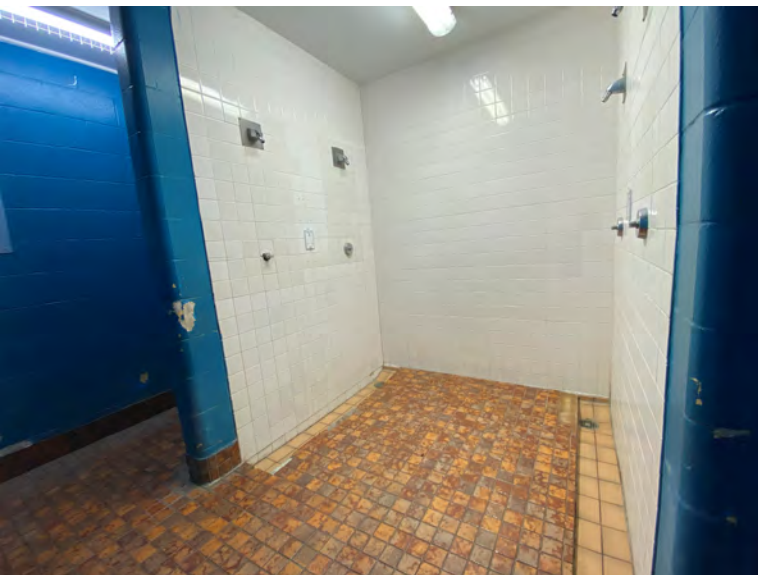
Changeroom Washrooms

The men's changeroom washrooms have urinals that are not accessible as they are elevated and do not have grab bars. There is inadequate space for wheelchairs to access the washroom adjacent to the urinals. That being said the washrooms located within the changerooms are non-accessible as they do not have a minimum 1500 mm turning radius for a person in a wheel chair to use the washroom.

Renovate washrooms to make them accessible with:

- » Accessible urinals
- » At least one accessible toilet stall
- » Lowered mirrors above accessible vanities (sinks)
- » An accessible shower stall

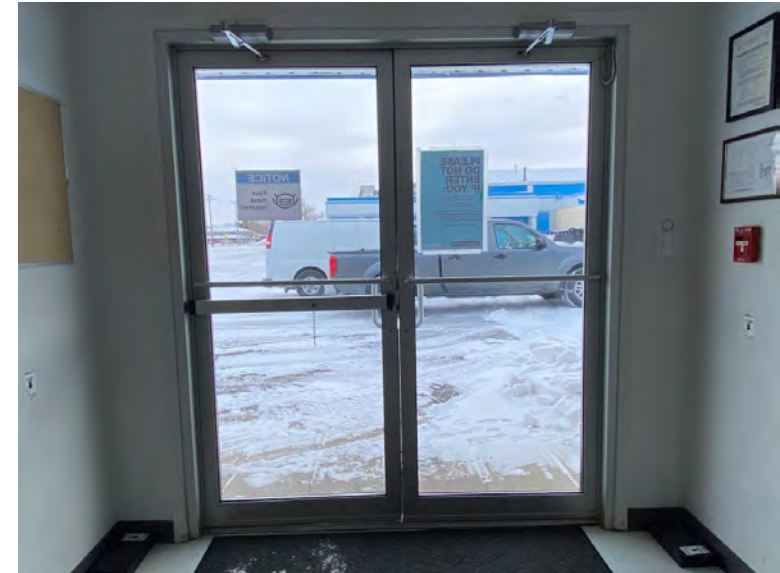
Main Entrance

All entrances to the Community Centre are at-grade and considered accessible.

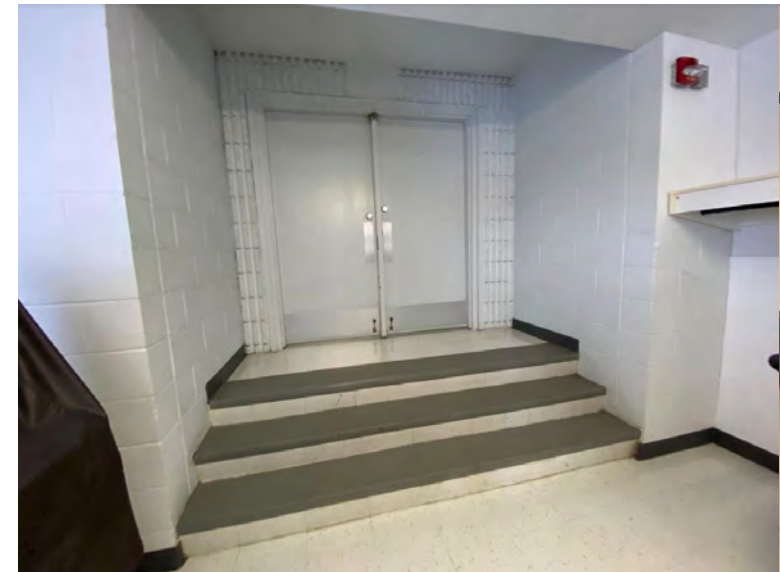
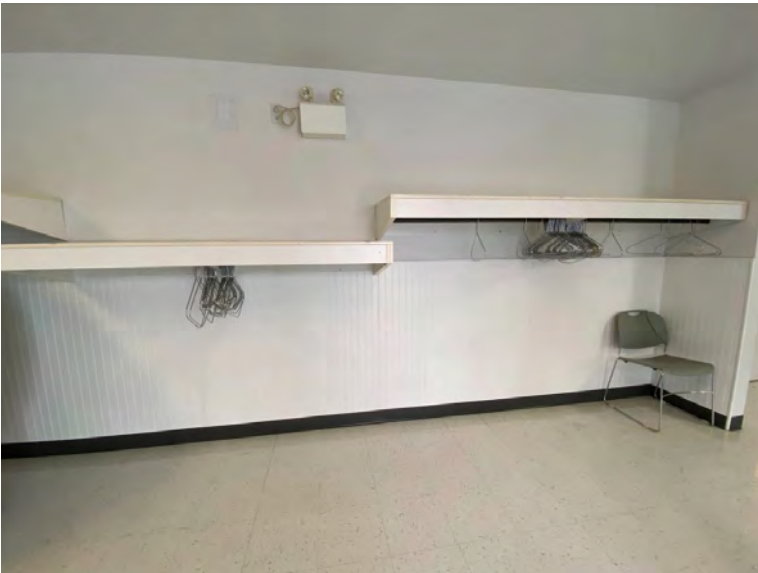
Curling Rink Interior Access

A stairwell acts as direct access from the Community Centre to the Curling Rink. However, the stairwell does not allow access for persons using a wheelchair.

- » Install an accessibility ramp on a portion of the existing staircase
- » This set of doors is a secondary entrance to the Curling Club. The external exit door of the curling club, adjacent to the entrance, is used as an accessible entrance (refer to Curling Club for information). A ramp in this location needs to be up to 9 m long which will impact circulation in the lobby

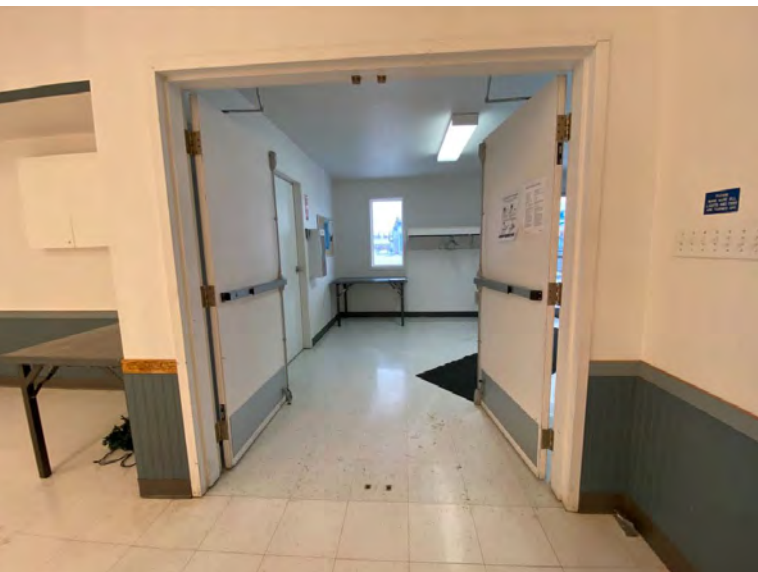
Foyer Entrance

The foyer entrance has existing wall-mounted coat racks, which has a lower space accessible to persons in a wheelchair. In addition, the doorway leading into the general area of the community centre is adequately sized and can be propped open to allow barrier-free access.

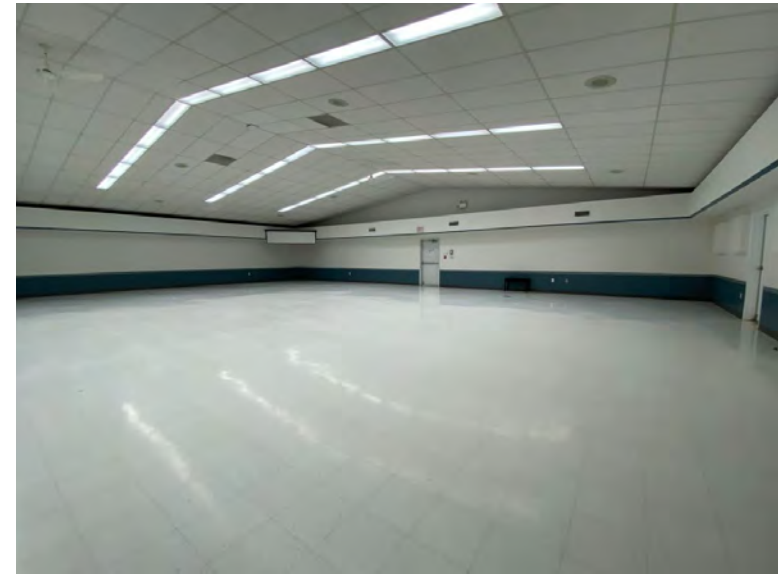
General Space

The main room of the community centre is an open-space that can be configured to accommodate accessible use.

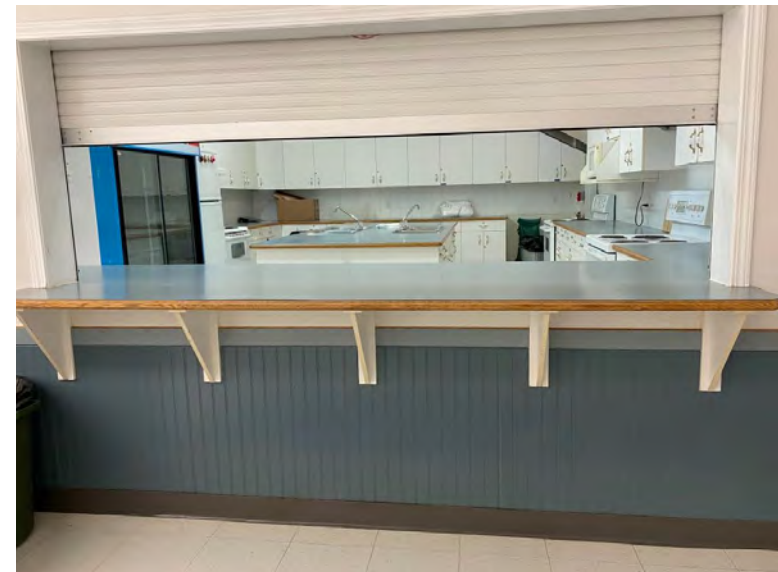
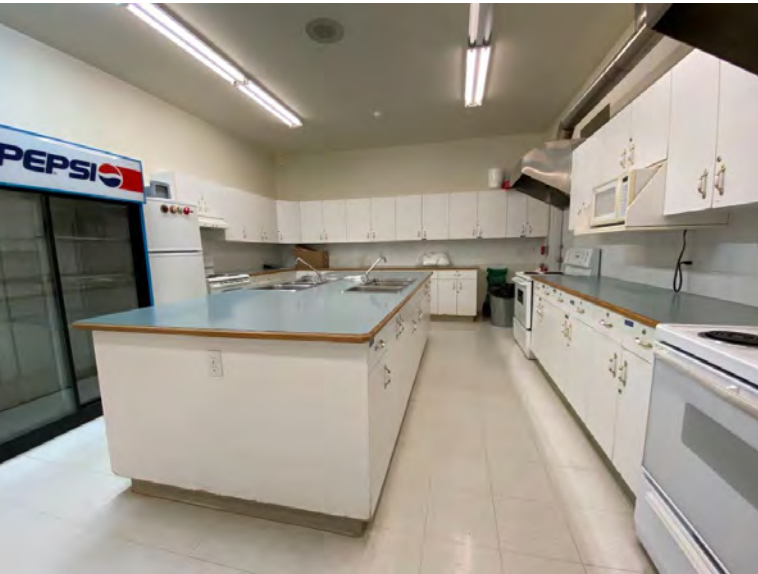
Serving Counter

The serving counter is accessible for persons in a wheelchair and located at an ideal height.

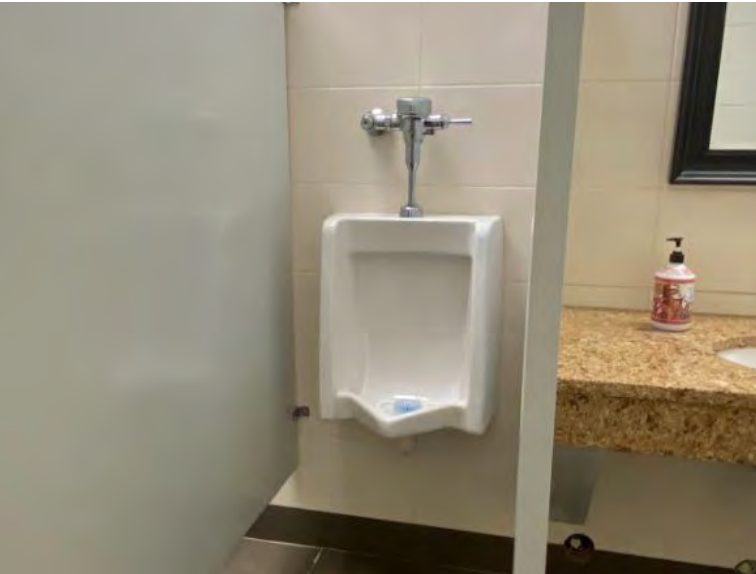
Men's Urinal

The men's urinal would benefit from the installation of grab-bars.

- » Installation of grab-bars on both sides of the urinal

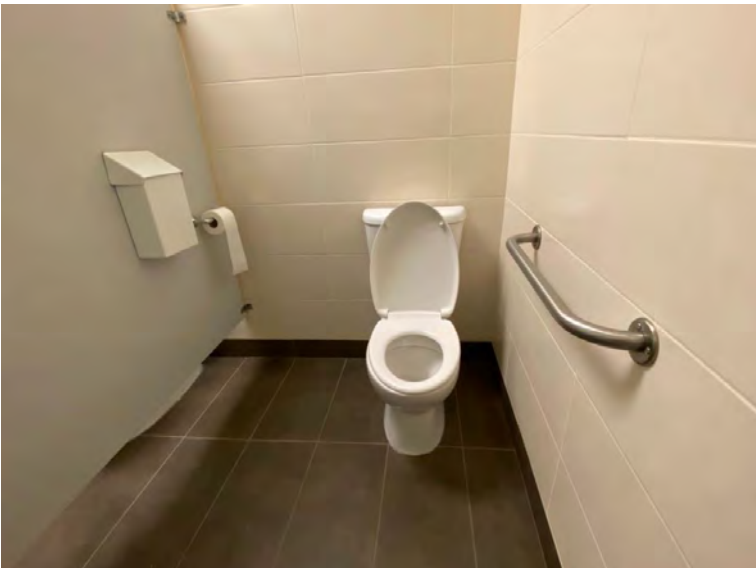
Accessible Stalls

Accessible stalls are located in washrooms that are of adequate size. However, toilet roll holders are awkwardly placed making it difficult to access for persons with limited mobility. Ideally, the grab bars would also have a vertical component to allow users to lower themselves or assist in pulling themselves up.

- » Relocate toilet roll holders to an accessible location near the existing grab bars

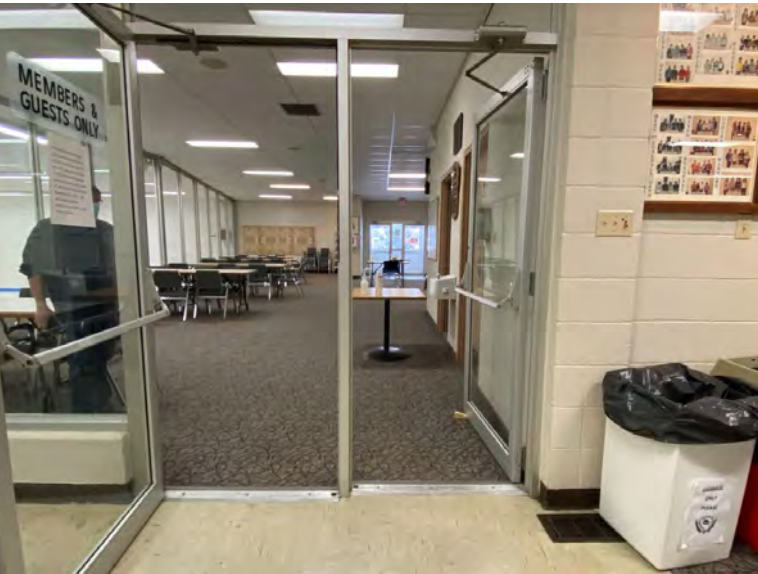
Interior Doorway

Within the Curling Rink there is an existing doorway between spaces with adequate clearance for wheelchair or scooter users to pass through. However, there is an existing convenience issue as it is easier for people to move through a wider opening.

- » Review whether it is feasible to install a sliding glass door that meets fire exit requirements as this would allow for a full width opening when both spaces are used
- » The improvement may require alteration to the entire aluminum partition system in this location

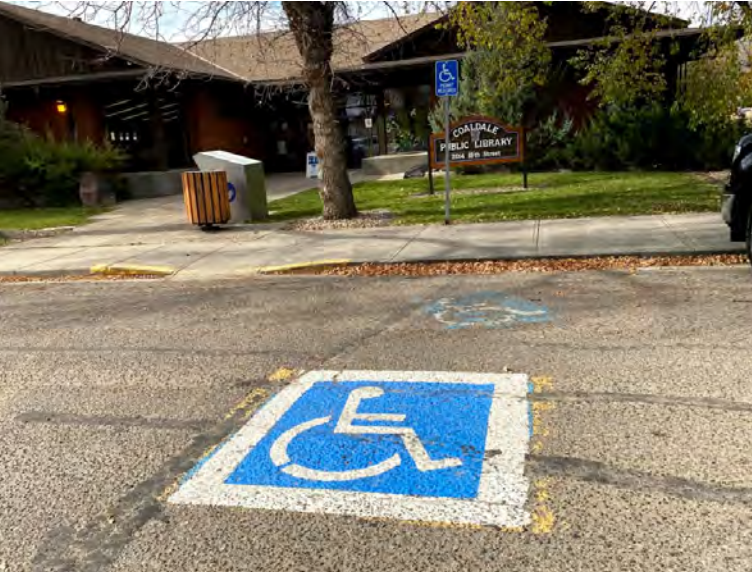
Parking

The number of barrier-free parking stalls at the Coaldale Library meets the Current Land Use Bylaw requirements and the central drop curb is located in an appropriate location. The parking stall currently has one barrier-free parking sign (vertically mounted sign).

However, it is difficult to distinguish the location of parking stalls as the existing paint is significantly worn, which may lead to confusion on the appropriate space or orientation needed to park the vehicle.

- » Re-paint parking stall lines to ensure appropriate barrier-free stall widths are identified
- » Paint a barrier-free path of travel adjacent to the barrier free stall and at the entry of the curb ramp for unloading purposes
- » Paint a barrier-free path of travel on the opposite adjacent side of the barrier free stall to ensure there is adequate space for individuals exiting from the right-hand side of a vehicle
- » Relocate the Barrier-Free stall to the left side of the curb-cut so the access aisle is on the right hand side of the vehicle and aligns with the curb cut

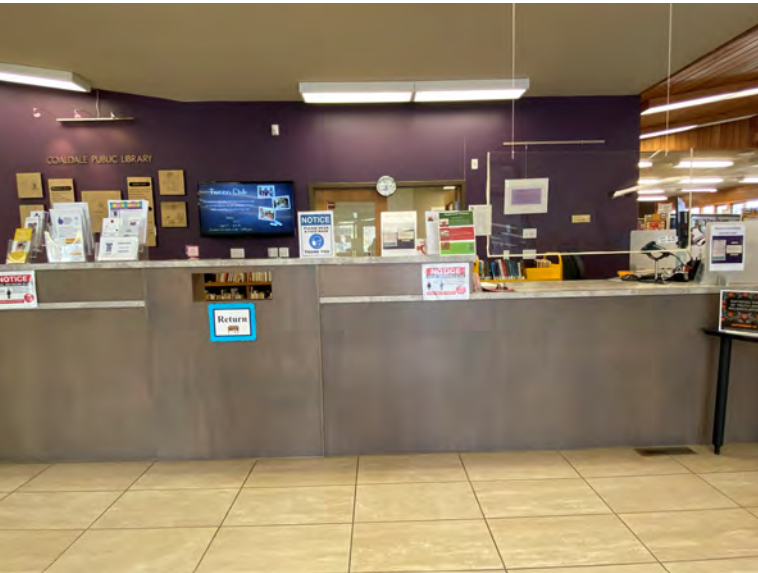
Service Counter

The Reception and Service counter did not include an accessible service counter at wheelchair height. In addition, there was no signage identifying an accessible counter nor did it have signage for an Assistive Listening System, which would be considered best practice.

- » Provide an accessible counter space at wheelchair level for equitable access to services

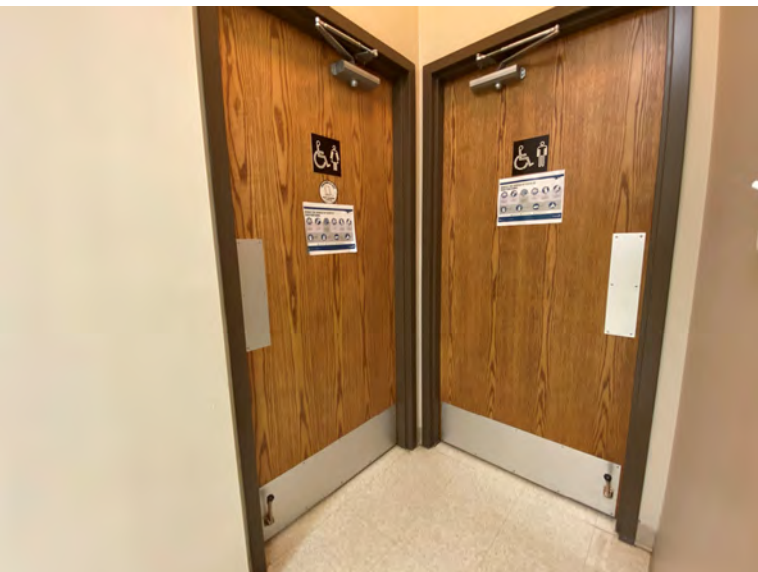
Washrooms

The entrance to the bathroom was not considered accessible due to non-power operated doors and a manual double-door entrance making it unsafe for a less able-bodied individual to access the bathroom alone.

- » Automatic doors should be considered for both men's and women's washrooms. However because the entry vestibules are tight access will still be difficult
- » Should the bathrooms be renovated at some point in time, a relocation of both men's and women's bathroom doors should be considered to allow ample space for persons entering and exiting the washroom
- » A family/gender neutral washroom would be beneficial if the washrooms were redesigned to improve access

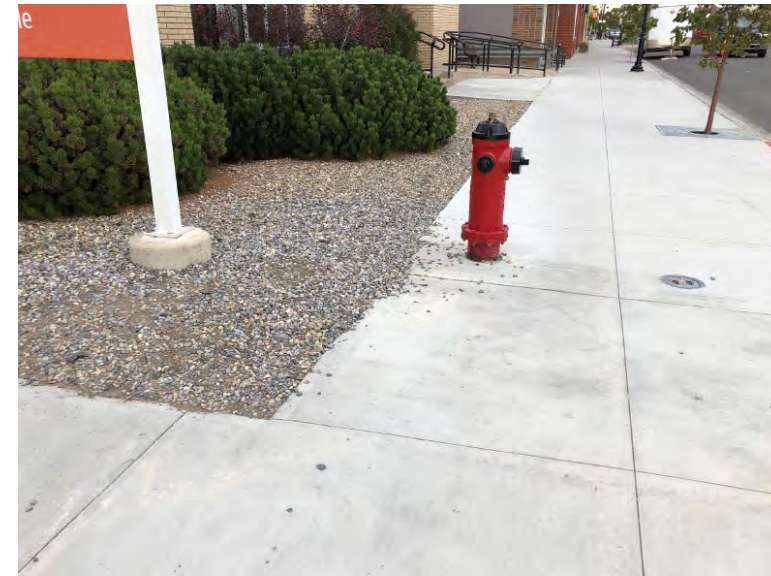
Exterior Street

While using the Town's new sidewalk system the only comment was for the Post Office. They have used large gravel as part of the landscaping in front of the building. There is no guard to stop the gravel from spilling onto the walkway and gravel has spilled onto the walkway creating a tripping hazard.

- » Request the Post Office to replace the material with something more suitable or provide a curb guard such as pressure treated wood along the edge of the walkway higher than the gravel to prevent gravel from easily being kicked onto the walkway

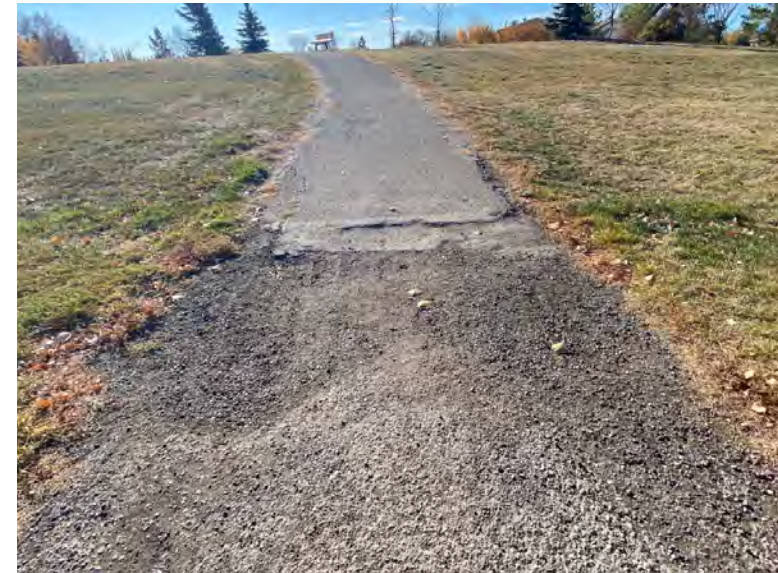
Surface

The pathway surface was generally in good condition and consistently level. The only area of concern included a section of the pathway that serves as a drainage ditch and may impact the path of travel during wet or cold temperatures.

- » For future pathways, avoid using sections of the pathway for drainage

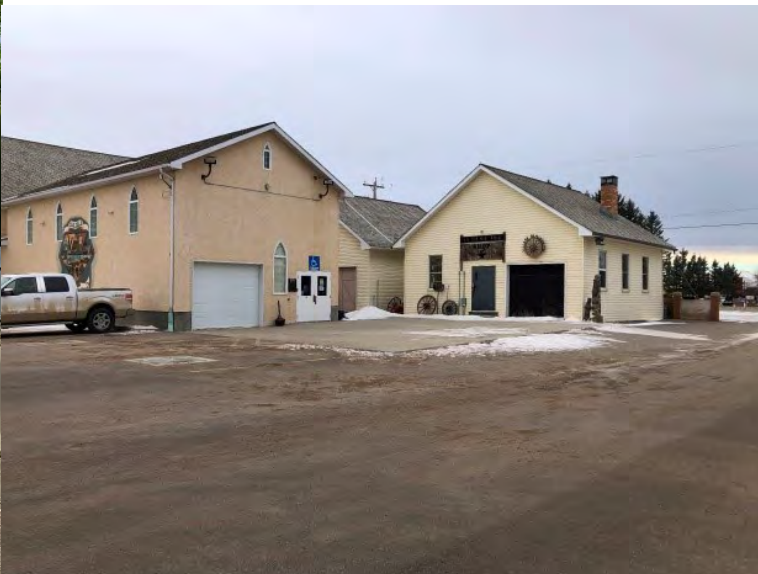
Gem of the West Museum

There are two barrier-free parking stalls located just north of the accessible entrance. However, there is no indication that a stall or drop-off location has been designated for Handi-Bus service.

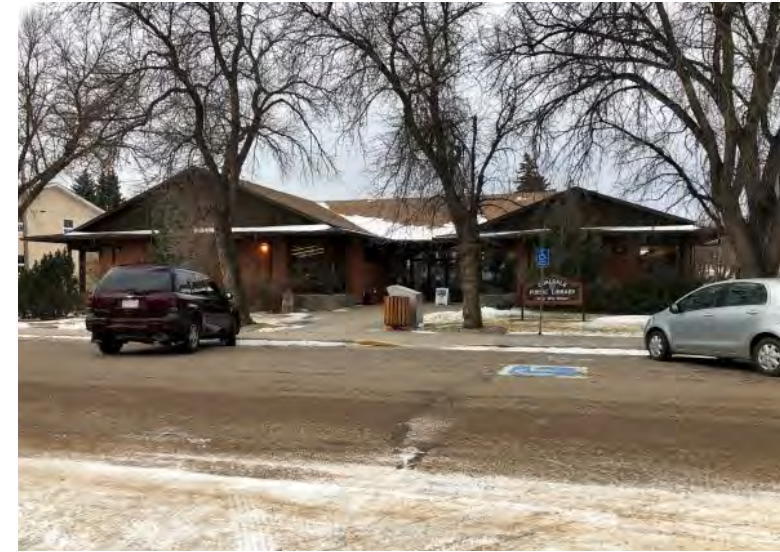
The existing Town Hall has parallel parking stalls on the street immediately adjacent to the ramp to enter the building. This is an ideal location for a barrier-free stall.

- » Until the new Town Hall is constructed, consideration should be made to dedicate the parallel parking stalls on the street for both a barrier-free stall and Hand-Ride pick-up/drop-off location

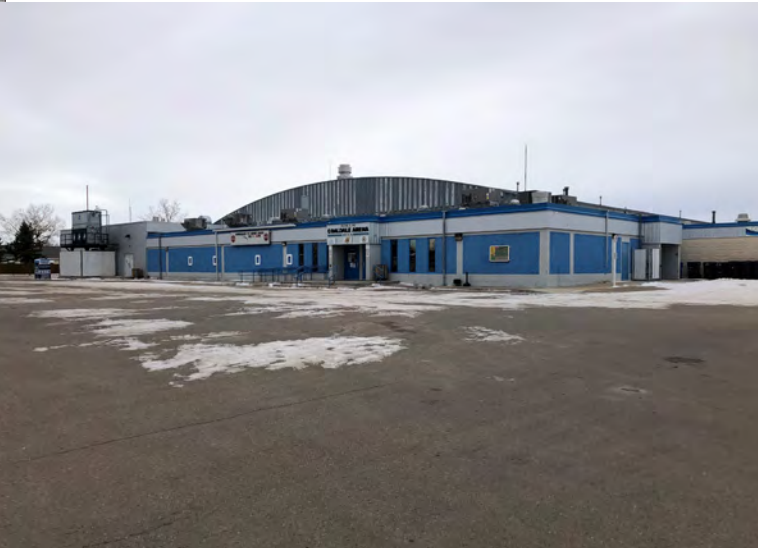
Coaldale Sportsplex

The existing Ice Rink, Outdoor Swimming Pool, Community Centre and Curling Club are all located in one area. While there are barrier-free parking stalls identified at the Pool and Ice rink, no Handi-Ride drop off locations were clearly indicated.

- » As the Ice Rink ramp is located a fair distance from the Pool and Community Centre entrances it may benefit from its own dedicated drop off location and Handi-Ride stall
- » It may be possible for the Pool and Community Centre to share a Handi-Ride drop off location, which could be a parallel stall on the west side of the pool parking area
- » In both cases the stalls should be clearly marked with access aisle and signage
- » It may be a consideration to redesign the complete parking lot and paint new stall and driveway lines to clearly identify vehicular movement, accessibility and service areas
